# VISTA RAILING SYSTEMS INC. TEST REPORT

REPORT OF 6 FT. FASCIA BRACKET ALUMINUM RAILING SYSTEM – 1-1/2 IN. PICKET TESTED  
IN ACCORDANCE WITH ASTM E935-21, *STANDARD TEST METHODS FOR PERFORMANCE OF  
PERMANENT METAL RAILING SYSTEMS AND RAILS FOR BUILDINGS*

105224861COQ-002B

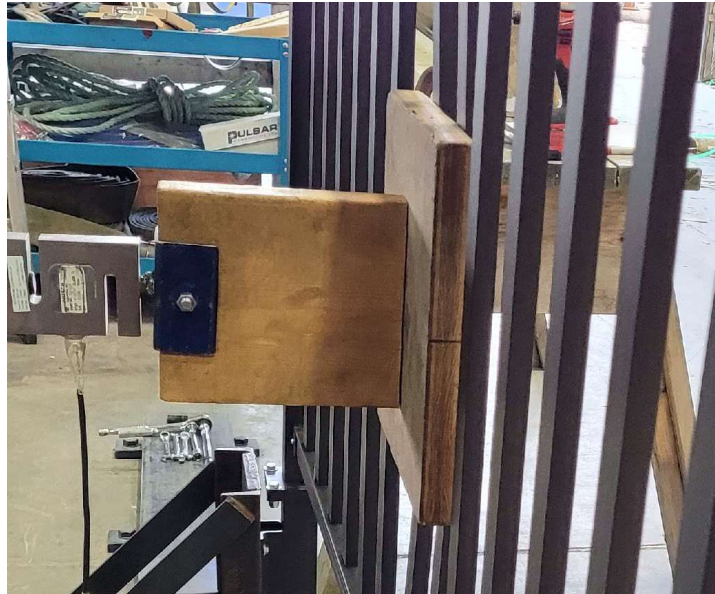
**Figure 1. In-fill Load Test**

The in-fill load test was conducted in accordance with Section 1607.9.1.2 *Guard Component Loads* of the 2021 IBC and Table R301.5 *Minimum Uniformly Distributed Live Loads* of the 2021 IRC. Testing was conducted with reference to Section 4.5.1 *Loads on Handrail and Guardrail Systems* of ASCE/SEI 7-10, *Minimum Design Loads for Buildings and Other Structures* with a safety factor of 2.5. A load of 125 lbs was applied using a 1 square foot block normal to the in-fill. After release of the load, the system was evaluated for failure, any evidence of disengagements of any component and/or visible cracking from any component.

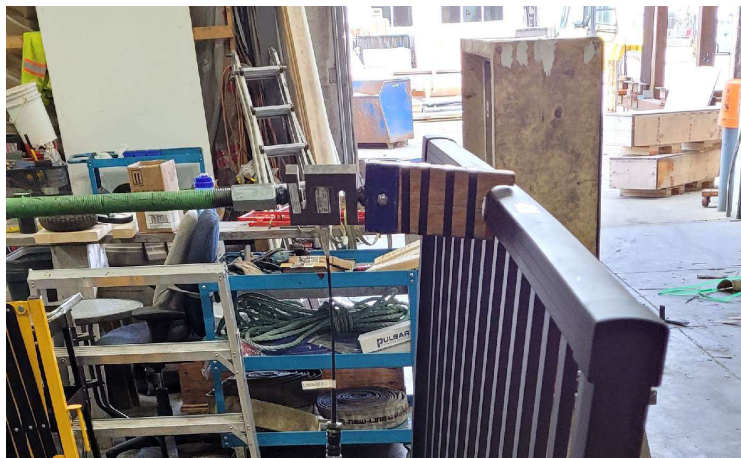
**Figure 2. Horizontal – Mid-Span of Top Rail Concentrated Load**

The concentrated load tests were conducted in accordance with Section 1607.9.1.1 *Concentrated Load* of the 2021 IBC and Table R301.5 *Minimum Uniformly Distributed Live Loads* of the 2021 IRC. Testing was conducted with reference to Section 4.5.1 *Loads on Handrail and Guardrail Systems* of ASCE/SEI 7-10, *Minimum Design Loads for Buildings and Other Structures* with a safety factor of 2.5. The top rail of the guardrail system was subjected to three (3) separate horizontal tests where a concentrated load of 500 lbs was applied:

- horizontally at the mid-span of the top rail,
- horizontally at the top rail adjacent to the post connection to verify the connection capacity, and
- horizontally at the top of the post.

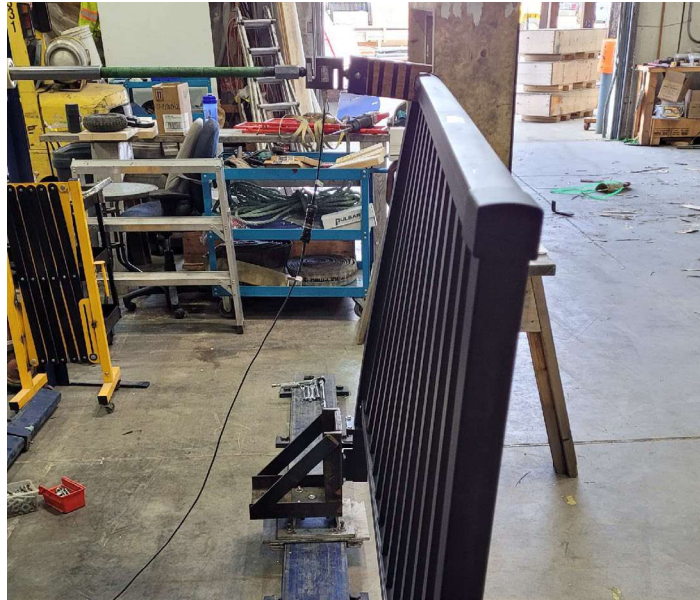
**Figure 3. Horizontal – Top Rail Adjacent to Post Connection Concentrated Load**

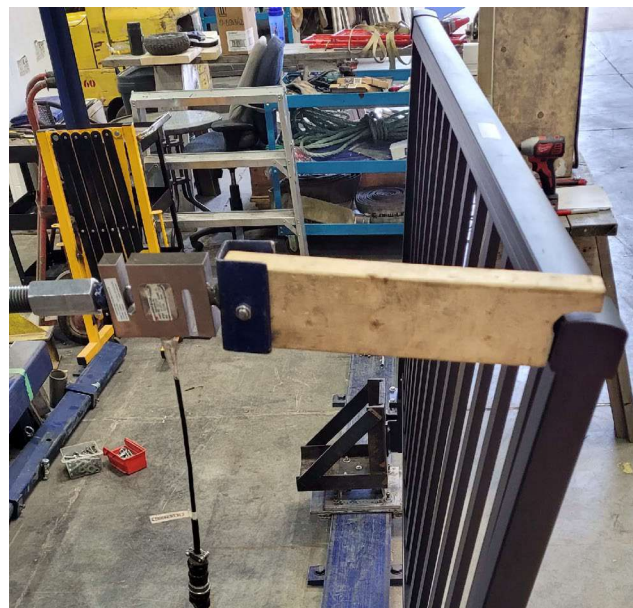
**Figure 4. Horizontal – Top of Post Concentrated Load**
